Inspection Report

PROPERTY INSPECTION REPORT

Concerning: 911 Sample Cir., Happy Land, Texas 0000001

By: JIM LARUE #8663 / J LaRue Services. LLC 6/3/2027

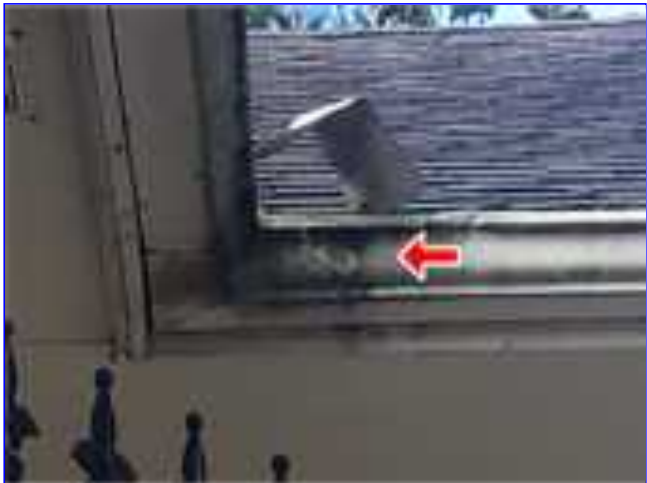
B. Item 1(Picture) Gutter

1. Gutters along the exterior of the residence were found to be in need of repair and servicing. Leaky seams, rusted areas and gutters that are full of pine needle and leaf debris were all found to be present at the time of this evaluation. Deficiency...Item 1(Picture)

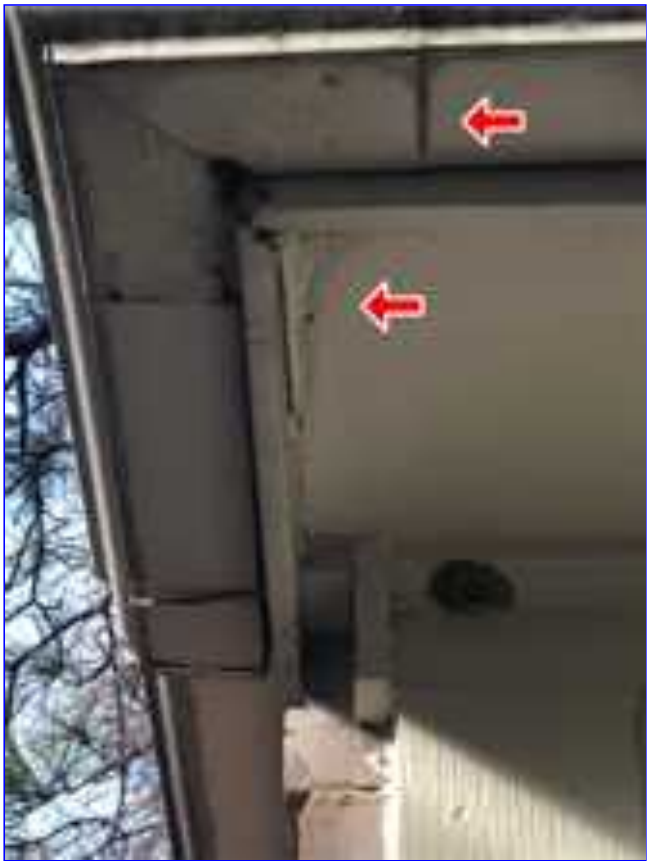
B. Item 2(Picture)

2. Fascia and soffit were found to be damaged due to moisture. This damage was found to be present within the atrium area on the left side rear. This damage is due to leaky and clogged gutters within this area. Deficiency...Item 2(Picture)

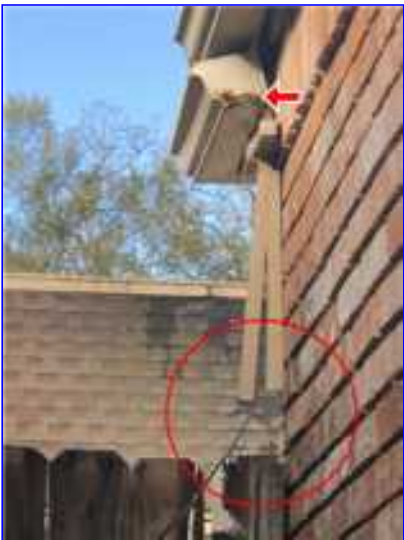
B. Item 3(Picture) Rear left corner

4. A section of gutter on the rear left corner of the structure (garage) was found to be in need of repair. The downspout in this area is discharging on the fence line and for this reason fencing is rotted out. Additionally, guttering within this area was found have rust spots and may need to be replaced or repaired. Deficiency...Item 3(Picture)

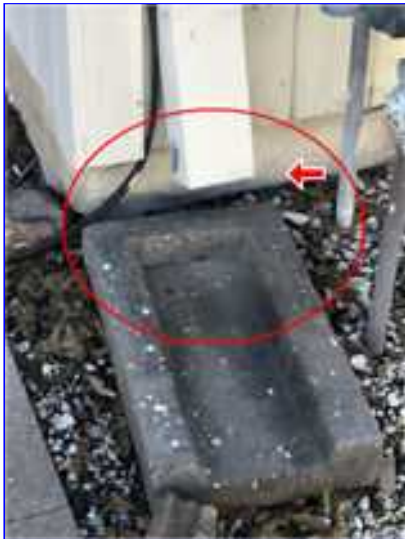
B. Item 4(Picture) Downspout/rear of structure

5. Gutter downspouts in all locations were found to be in need of repair. Downspouts are loose from the structure (missing strapping). Additionally, downspouts are missing elbows and splash blocks associated with these downspouts should be turned in the opposite direction so the closed end faces forward - this is intended to defuse water and limit erosion at and around these splash blocks. Deficiency...Item 4(Picture)

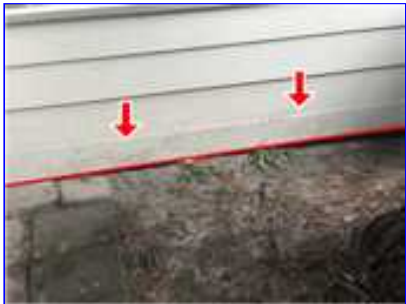
B. Item 5(Picture)

6. High soil and negative drainage were found to be present within the atrium area at the time of this evaluation. I recommend that this area be evaluated for a grading and drainage correction as standing water may be a problem in times of heavy rain. It should be noted that there is an area drain within this area. However, trees and other obstructions are present which may limit or slow water drainage within this area. Deficiency....Item 5(Picture)

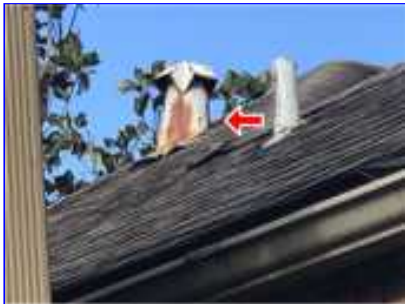
C. Item 1(Picture)

1. Roof jacks are in need of repair, caulking around vent piping is aged and separating, and nail heads are exposed in support of the roof jacks. Deficiency. Item 1(Picture)
2. Loose and damaged shingles were found to be present in the following locations (Rear right of garage): Deficiency.
3. Chafing of shingles were found to be present along the front of the residence. This would suggest the tree branches have rubbed up against the structure at some point in time and knocked off or removed granules. Deficiency....Item 2(Picture)
4. Missing drip edge and lifted shingles were found to be present along the rear right of the structure. Deficiency...Item 3(Picture)
5. An active roof leak was found to be present at and around roof jacks. Deficiency. Item 4(Picture)- Item 5(Picture)

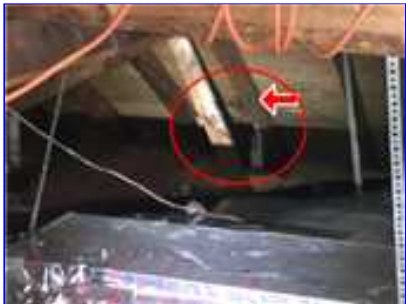
C. Item 4(Picture) Rear attic space

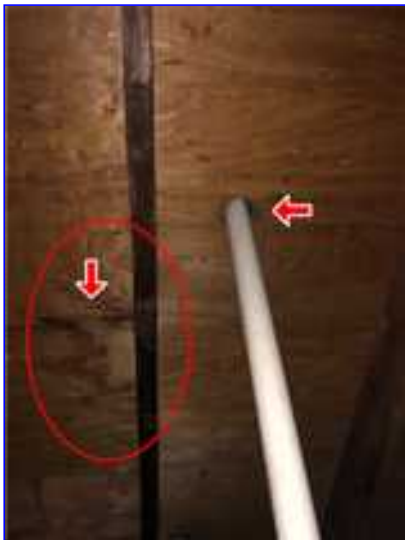
C. Item 5(Picture) Front attic space

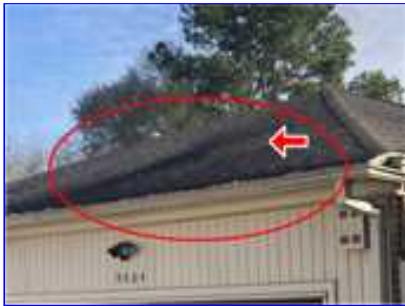
D. Item 1(Picture)

1. Depression - what appears to be a depression within the roof decking was found to be present along the rear of the garage. This may be due to limited support within this area and it is recommended that all necessary corrections or repairs be applied at the next roof covering replacement. Deficiency...Item 1(Picture)
2. Limited decking was found to be present to the mechanicals in the attic accessible by the secondary bathroom at front of the residence. Deficiency....

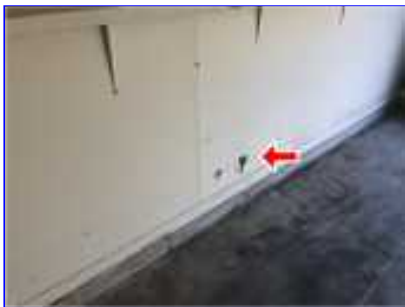
E. Item 1(Picture)

1. Damage sheet rock was found to be present along the left-hand side of the garage. Two holes were found to be present within this area. Deficiency....Item 1(Picture)

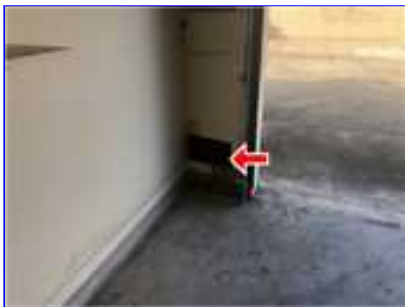
E. Item 2(Picture)

2. Open sheet rock was found to be present at the rear left wall in support of the garage door rail. I recommend that you consult with the seller in regards to the reason behind this opening. Deficiency....Item 2(Picture)

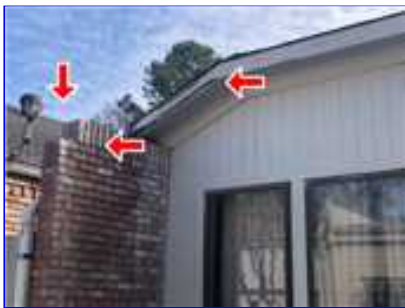
E. Item 3(Picture)

4. The exterior brick wing wall at the rear right of the structure was found to have loose and missing brick along the top leading edge of the wall. Additionally, the wall cap or mortar cap within this area is missing. Deficiency....Item 3(Picture)

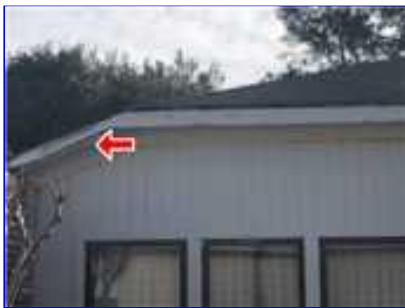
E. Item 4(Picture)

5. Damaged exterior fascia and soffit were found to be present along the rear of the structure. I recommend that all needed or necessary repairs be applied. Deficiency...Item 4(Picture)

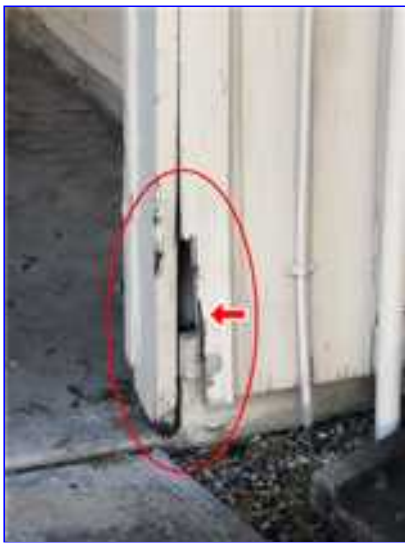
E. Item 5(Picture)

6. Siding and trim work to include the garage door trimmers were found to be damaged and in need of repair/replacement. I recommend that these members be properly repaired and/or replaced as needed. Deficiency....Item 5(Picture)

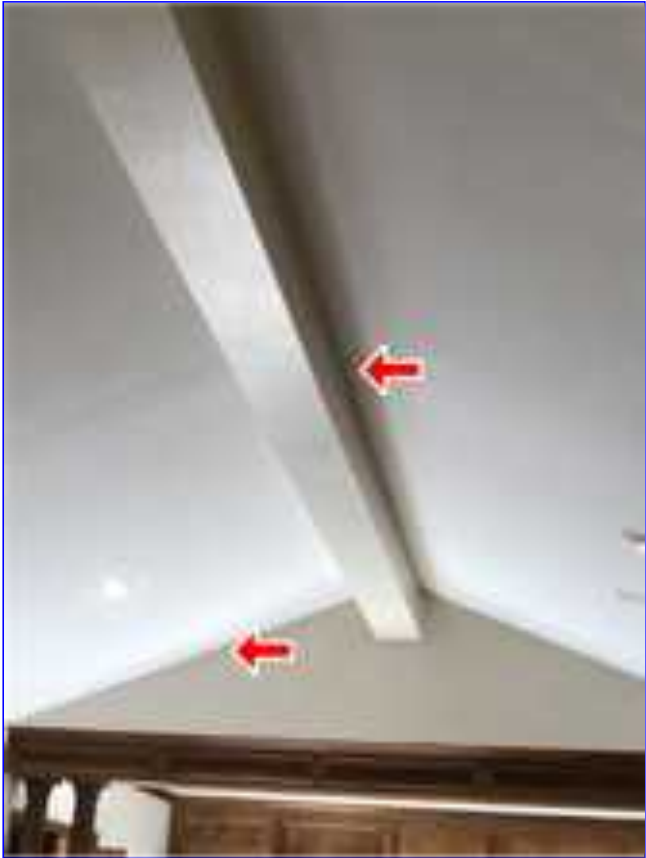
F. Item 1(Picture)

1. Settlement cracking was found to be present within the ceiling area along the false beam and rafter area leading into the dining room/kitchen. These cracks appear to be cosmetic in nature and appear to be from routine settlement. I recommend that they be monitored and all needed or necessary corrections be applied. Deficiency...Item 1(Picture)

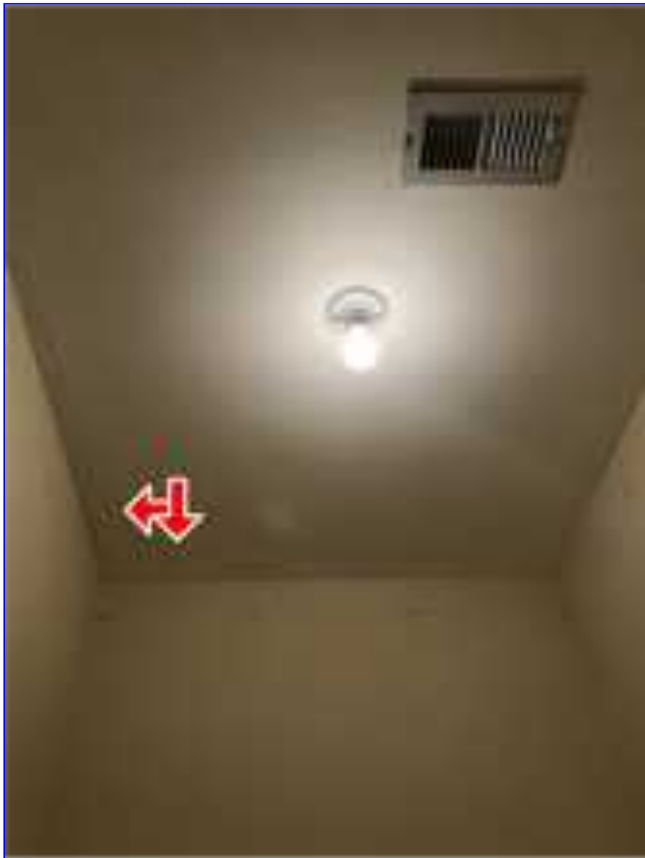
F. Item 2(Picture)

3. Water staining was found to be present in one of the two master closets and in the rear bedroom area. The stains were tested with a moisture meter and moisture levels were found to be normal or 00. I recommend that all needed or necessary repairs be applied. Deficiency...Item 2(Picture)

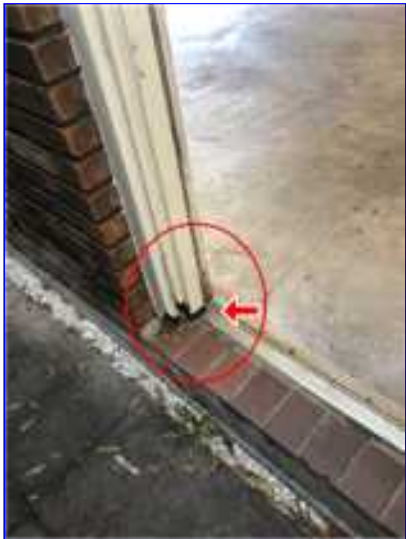
G. Item 2(Picture)

1. The main entry door to the residence was found to have damage due to weather. Paint associated with this door unit is starting to crack and openings within the finish were found to be present. It should be noted that paint is a consumable and over time it will need to be redone or replaced. I recommend that all necessary or needed repairs be applied and that this unit be repainted to the color of your choice. Deficiency...Item 1(Picture)
2. The side entry door to the garage (left side) was found to have extensive water damage at both the left and right hand sides of the door jamb. This unit will be a candidate for replacement and it is strongly recommended that some form of water break be installed on the roof line above this

door. This water break should help shed water to the left and right of the unit and limit damage as it appears that water is splashing back up on this area due to excessive water runoff.

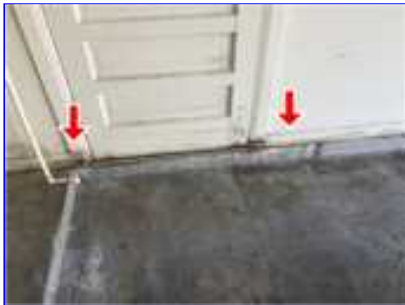
G. Item 3(Picture)

3. Baseboard along the interior side of the garage wall shows significant evidence of water damage. This baseboard tested negative for excessive moisture at the time of this evaluation. However, this is evidence in support of comment number two within the section. I recommend all needed or necessary repairs be applied and it should be noted that prolonged exposure to moisture within these areas may allow for fungal growth that cannot be seen or tested for within the course of a normal property inspection. I recommend that all needed or necessary repairs be applied.

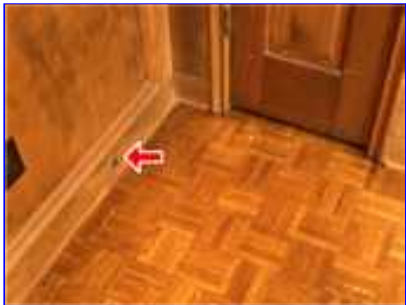
G. Item 4(Picture)

4. Doorstops in two or more locations throughout the residence were found to be missing. I recommend that doorstops be reestablished as they are intended to protect walls from damage.

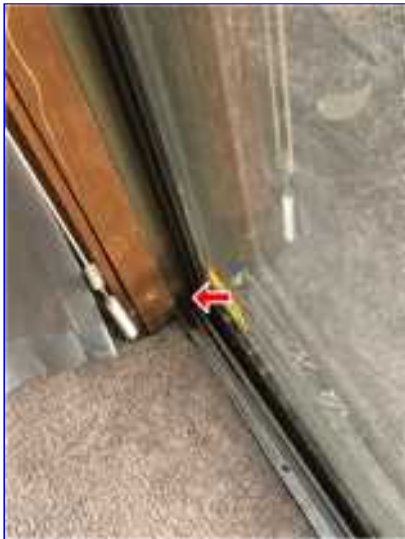
G. Item 5(Picture)

5. Evidence of moisture was noted at the wood members at sliding glass doors. This discoloration is most likely from sweating due to the aluminum door frame and normal use during wet times. I recommend that these areas be considered for refinishing and all needed or necessary repairs be applied. Deficiency...Item 5(Picture)

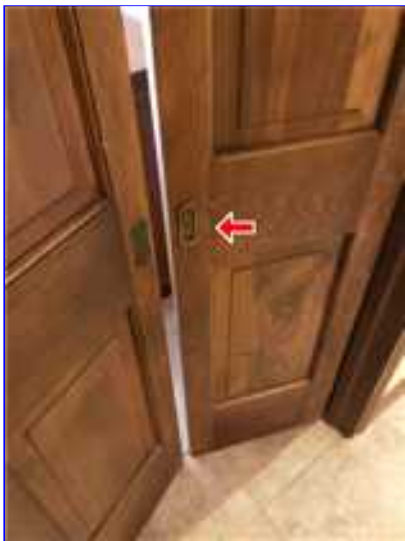
G. Item 10(Picture)

10. Double doors in the hallway area at the rear the residence were found to be missing door hardware. Deficiency....Item 10(Picture)

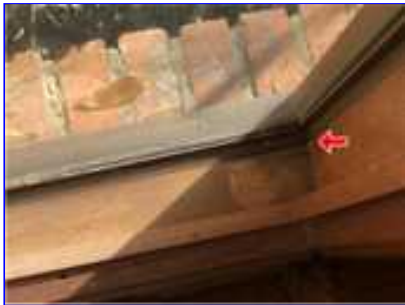
H. Item 1(Picture)

1. Water staining was noted in one or more window locations throughout the residence. The staining is common with aluminum frame windows as they sweat and in doing so moisture condensates on the interior side of the window frame and stains wood members. I recommend that all needed or necessary repairs be applied to wood members and that they be properly sealed to eliminate any further damage. Deficiency...Item 1(Picture)

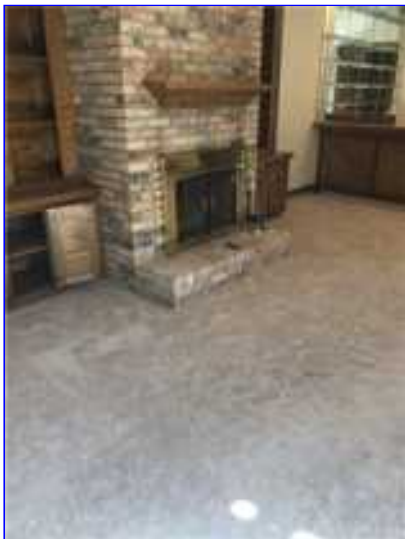
J. Item 1(Picture)

- Comments:**
1. Residence was found to have a wood burning fireplace with an LP gas log starter. This unit has been converted for fire logs. At the time of this inspection the remote would not operate the internal unit within the fireplace. I recommend that this unit be evaluated for repair and that all needed or necessary repairs be applied. Deficiency....Item 1(Picture)

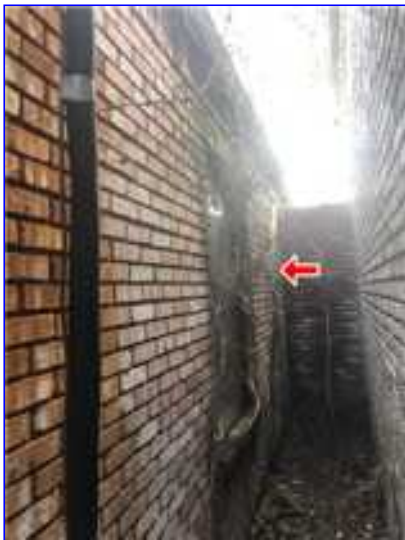
L. Item 3(Picture)

- 3. Fungal growth/vines were found to be present on the left-hand side of the structure between the two units. I recommend these vines be removed as overtime they may damage the veneer of the brick and/or exterior finishes. Additionally, these vines are a haven for unwanted pests. Deficiency....Item 3(Picture)

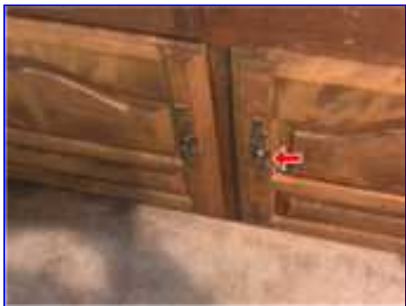
L. Item 4(Picture)

- 4. Cabinetry in the master bathroom was found to be missing cabinet pulls at several locations. While the hardware is still present the actual knob has been removed. Deficiency....Item 4(Picture)

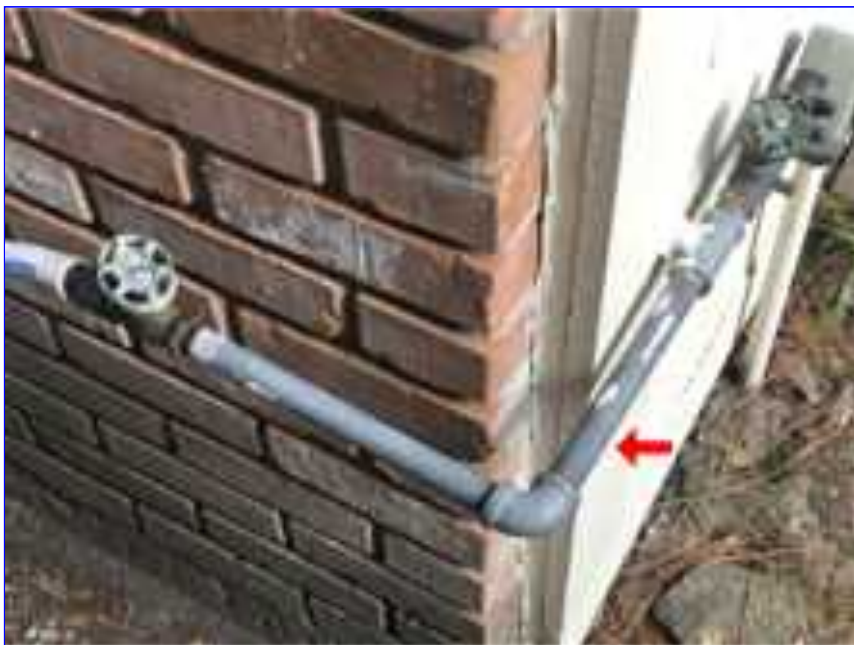
A. Item 5(Picture)

4. Exposed water piping was found to be present on the exterior rear of the residence. This water piping is in support of a sink which has been installed in the garage. This installation lacks skilled craftsmanship and I recommend that it be reconsidered in its configuration. Deficiency...Item 4(Picture)
5. Water piping within the atrium/solarium area extends out and around the corner of the wall leading to the rear walkway area. This piping is cantilevered and unsupported and un-insulated. I recommend that consideration be made into shortening and re-positioning this water piping as it is easily damaged. Deficiency....Item 5(Picture)

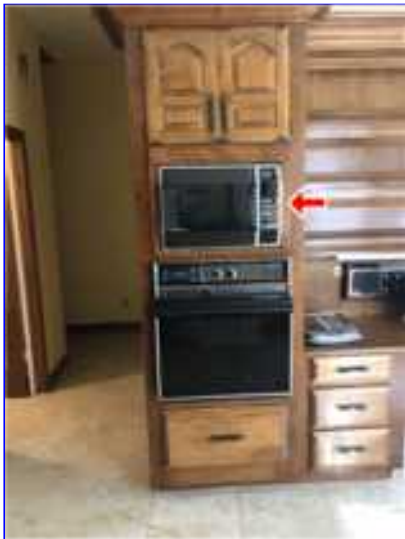
E. Item 1(Picture)

- 1. The unit was found to be operational at the time of this inspection. However, some controls were found to be aged and intermittent. Deficiency....Item 1(Picture)

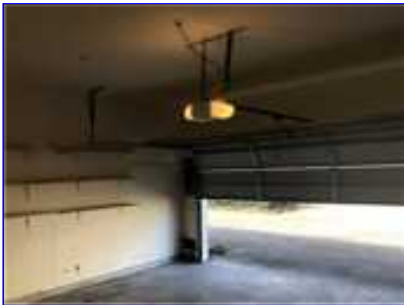
G. Item 1(Picture)

- 1. The garage door opener was found to drag slightly at both opening and closing of the unit. I recommend that this unit be evaluated for repair. Deficiency....Item 1(Picture)

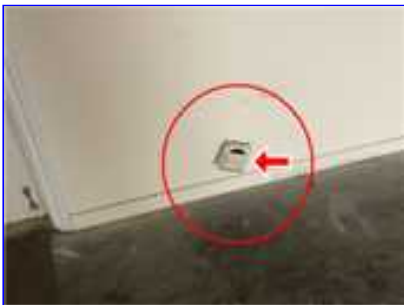
H. Item 1(Picture)

- 1. Item 1(Picture) The dryer is discharging into the garage space. It is recommended that a proper catch or lint box be installed as currently lint is migrating through the garage into places like electrical outlets and the main breaker panel. Deficiency...Item 1(Picture)
