Inspection Report

PROPERTY INSPECTION REPORT

Concerning: 911 Sample Cir., Happy Land, Texas 0000001

By: JIM LARUE #8663 / J LaRue Services. LLC 6/3/2027

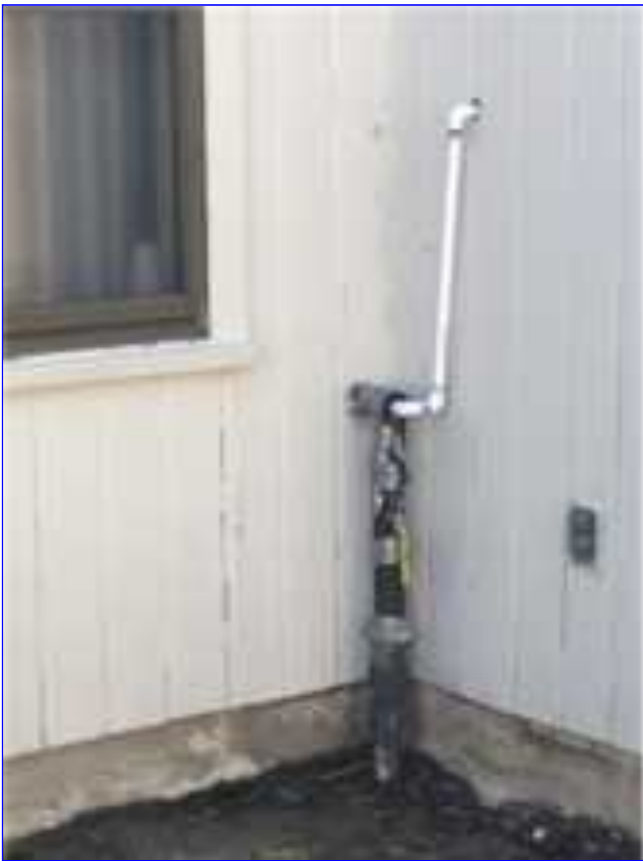
A. Item 4(Picture)

4. Exposed water piping was found to be present on the exterior rear of the residence. This water piping is in support of a sink which has been installed in the garage. This installation lacks skilled craftsmanship and I recommend that it be reconsidered in its configuration. Deficiency...Item 4(Picture)
5. Water piping within the atrium/solarium area extends out and around the corner of the wall leading to the rear walkway area. This piping is cantilevered and unsupported and un-insulated. I recommend that consideration be made into shortening and re-positioning this water piping as it is easily damaged. Deficiency....Item 5(Picture)

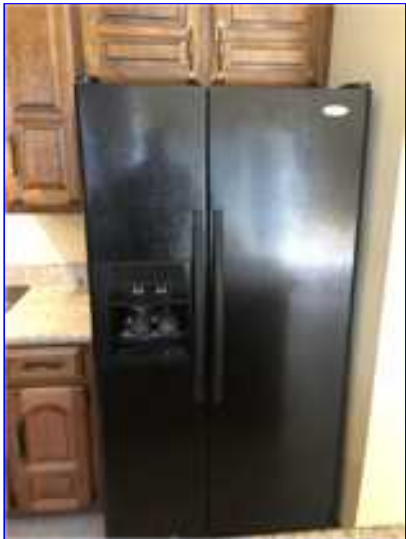
I. Item 2(Picture)

- 1. An icemaker was found to be present within the bar area. At the time this inspection the unit was turned off and therefore must be assumed to be inoperative. Deficiency...Item 1(Picture)
- 2. The refrigerator was found to be aged but operational. All door functions were found to be working and at the time of this evaluation the unit was producing ice. This unit is in need of proper cleaning. Deficiency...Item 2(Picture)
